The Effects of Corrosion, Fatigue, and Corrosion-fatigue of Multilayer Coated Polyesters for Flexible Electronics Applications

Mohammed, Dilveen; Ameen, Rayan; Street, Steven; Sierros, Kostas; Bowen, James and Kukureka, Stephen (2021). The Effects of Corrosion, Fatigue, and Corrosion-fatigue of Multilayer Coated Polyesters for Flexible Electronics Applications. e-Journal of Surface Science and Nanotechnology, 19 pp. 61–68.

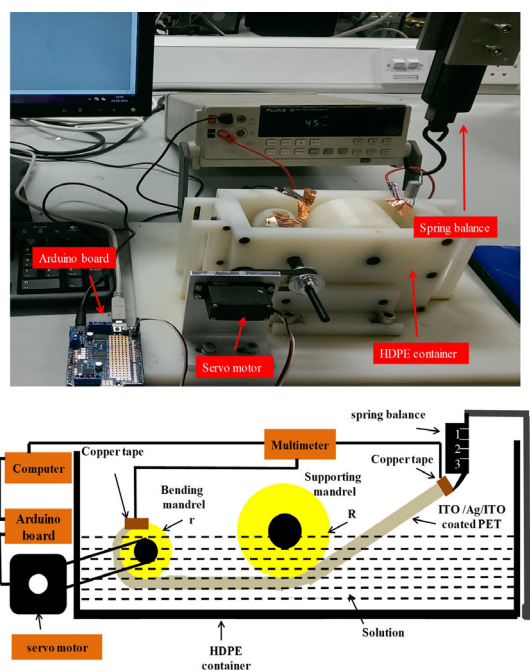
Figure 1: Photograph and schematic diagram of the custom-built bending fatigue apparatus.

Corrosion-fatigue experiments were performed using a custom-built cyclic uniaxial bending apparatus based on that used by Bejittual *et al.* [19]. A schematic diagram and the setup of this apparatus is shown in Figure 1. The sample was wrapped over a mandrel made from chlorinated polyvinyl chloride (c-PVC) on one end and it was fixed to a spring balance at the other end. The copper conductive tape was used at each end of the sample to allow optimized electrical contact for resistance measurements. A large c-PVC mandrel ($R \gg r$) supported the sample in the horizontal position and prevented sagging of the sample. A servomotor was utilized to rotate the mandrel with the reciprocating rotary motion controlled by a board driven using the Arduino software. The tests were run at a fixed reciprocating frequency of 2 Hz. Each test was carried out for 115200 cycles. The response of the film in terms of the electrical resistance was monitored *in situ* using the multimeter (Fluke 45).

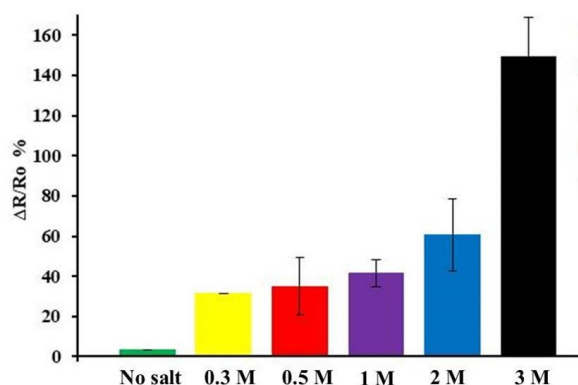
Figure 3: The effect of various concentrations on normalized electrical resistance of ITO/Ag-alloy/ITO film after 57600 s.

until around 15000 s and then an increase is noticed. After 57600 s of immersion, the change in the electrical resistance was 31.4% for 0.3 M and 35.2% for 0.5 M, as shown in Figure 3. For samples immersed in 2 M NaCl, a higher increase in the electrical resistance was observed, indicating faster corrosion of the ITO/Ag/ITO films as compared to the samples immersed in the lower NaCl concentrations. After 57600 s, a ~60.7% resistance increase is observed (Figure 3). The electrical resistance trace of ITO/Ag-alloy/ITO when exposed to 3 M NaCl shows that a higher concentration of NaCl makes an ITO/Ag/ITO coating susceptible to a more rapid corrosion process. After 57600 s of experimental testing, the increase in the electrical resistance is observed to be

~149.5% (Figure 3). We anticipate that, if the experiment is conducted for a significantly longer period, the ITO/Ag-alloy/ITO film would experience total corrosion leading to a catastrophic electrical conductivity decrease.

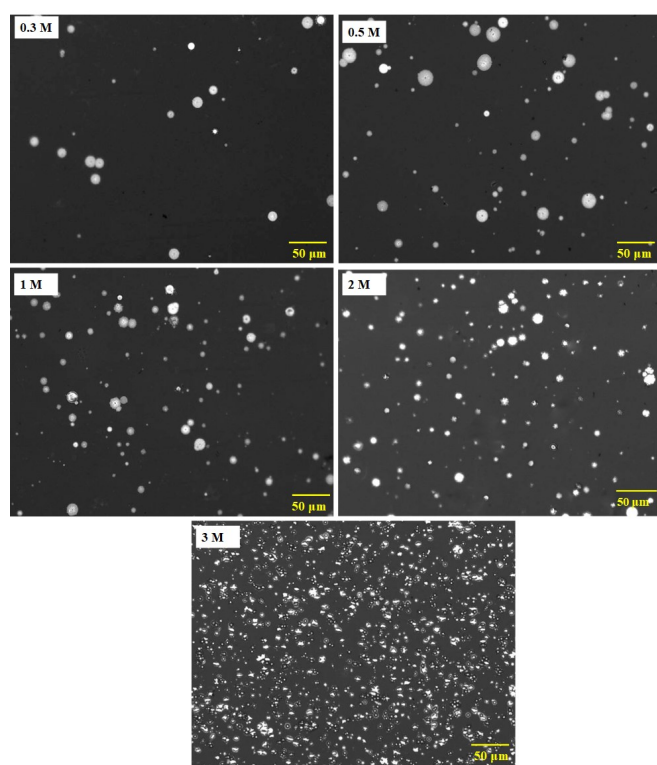
Figure 4: CLSM images of the surfaces of ITO/Ag-alloy/ITO immersed in NaCl of various concentrations for 57600 s.

Figure 4 displays the progressive morphological degradation for ITO/Ag/ITO immersed in NaCl of various concentrations for a total of 57600 s. The samples immersed in 0.3 M were degraded, showing a number of white spots. The samples that were immersed in 0.5, 1, 2, and 3 M exhibited less degradation, although they exhibited a number of white spots in places. The samples immersed in 3 M were more degraded in comparison to the samples immersed in 0.3, 0.5, 1, and 2 M of the solutions, and a high number of corrosion spots was observed covering almost the whole surface of the sample. These observations agree with results in term of the electrical resistance changes over time obtained for all concentrations.

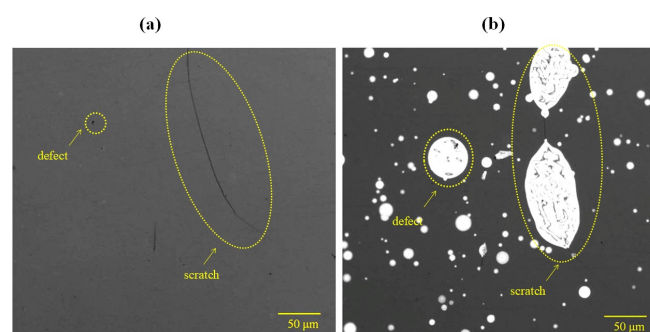
Figure 5: CLSM images showing the coating defects and scratches on the ITO/Ag-alloy/ITO surfaces before (a) and after (b) immersion in 0.5 M for 57600 s.

The corrosion mechanisms have been studied by Koike *et al.* [15], who suggested that the chloride ions (Cl^-) attacked the ITO surface, passed through the top ITO layer, and reached the Ag layer. Then, the Ag atoms aggregate around the chlorine atoms to form the white clusters. Besides that, in our work, the pre-existing defects and scratches on the surface resulting from the deposition process and from handling were found to serve as nucleation points of the corrosion products (or Ag agglomerations) which appeared as white areas on the CLSM image in Figure 5. Defects and scratches in the layer are believed to facilitate the movement of Cl^- to reach the Ag layer and enhance the agglomeration

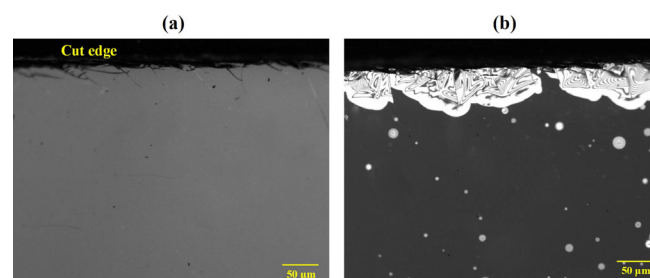
Figure 6: CLSM images showing the edge defects initiated upon cutting of ITO/Ag-alloy/ITO before (a) and after (b) immersion in 0.5 M for 57600 s.

Apart from Cl^- penetration through permeable defects or scratches on the coating, the Cl^- ions could also penetrate through small cracks formed at the edges after sample cutting, as shown in Figure 6. This implies that, during cutting of specimens or fabricating of patterned electrodes in the photolithography process, care must be taken to enhance edge resolution and fidelity and to avoid edge-generated

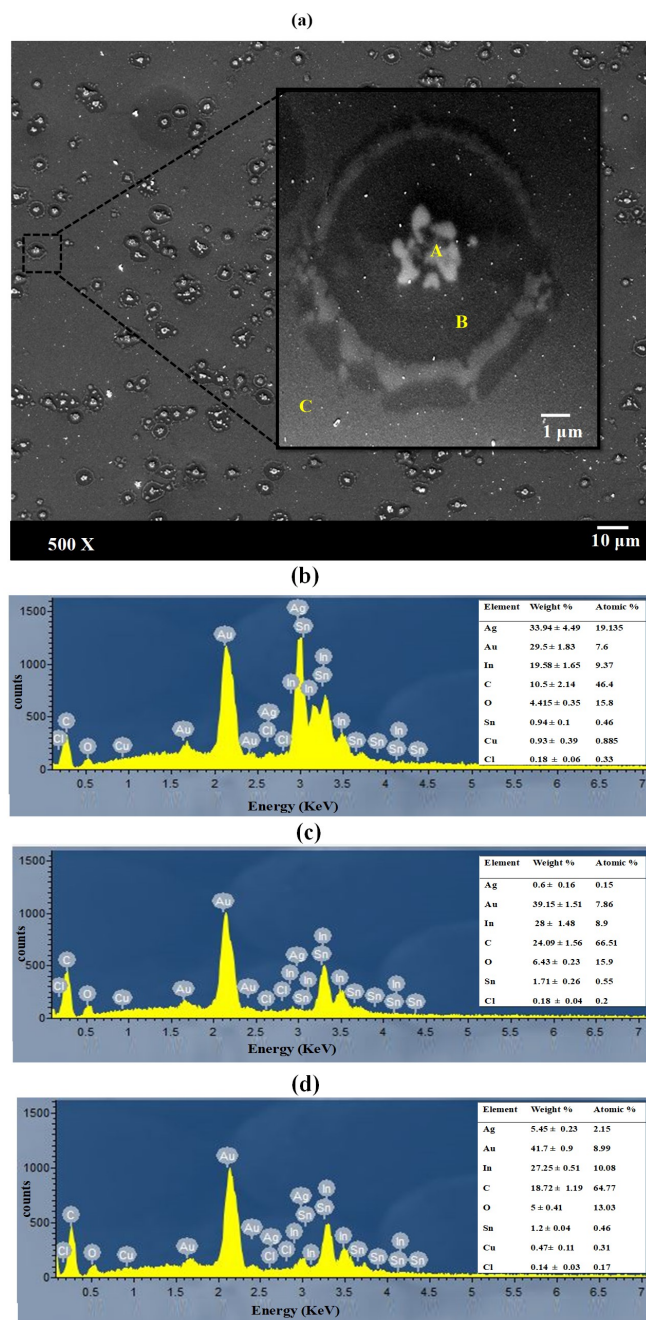
Figure 7: (a) SEM micrograph of the ITO/Ag-alloy/ITO surface immersed in the 3-M NaCl solution for 57600 seconds. (b–d) EDS spectra obtained from regions A (b), B (c), and C (d) indicated in panel (a). Inset is the table showing the percentage of each component in the film.

The samples immersed in 3 M NaCl were also investigated using EDS to clarify the corrosion product elements for the ITO/Ag-alloy/ITO film. EDS spot-scan analysis of surface failures and elemental mapping analysis are shown in Figures 7 and 8. The cluster of bright particles in the center of the image in region A is Ag-rich and slightly depleted in In and Sn. Along the circular edge of area in region B, there are periodic agglomerations that are rich in Ag, but still exhibiting higher concentrations of In and Sn. In all areas of the sample, no removal of In and Sn was detectable, i.e., the Sn/In ratio of the ITO film at region A is ~ 0.044 , which is similar to that in the unaffected area (region C), suggesting that both top and bottom ITO layers have not been removed. Eight other damage spots have been examined and yielded similar results. The high carbon content is most likely due to the PET substrate.

A tiny amount of Cu was also found in regions A and C and is most likely due to the Ag alloy constituent. The Cu content in region A is 0.93 ± 0.39 wt%, which is higher than that in other regions. Cho and Lee [21] investigated the role of Cu additions in the Ag alloy deposited between layers of indium zinc oxide and found that Cu did not improve the stability of the Ag-alloy layer but did improve thermal stability.

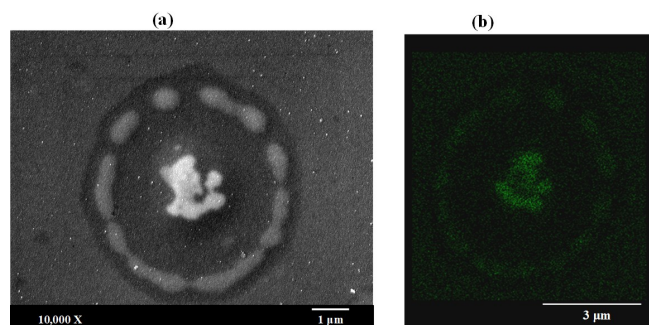
Figure 8: (a) SEM micrograph of the ITO/Ag-alloy/ITO surface after 57600 s submerged in the 3-M NaCl solution. (b) EDS mapping image of Ag.

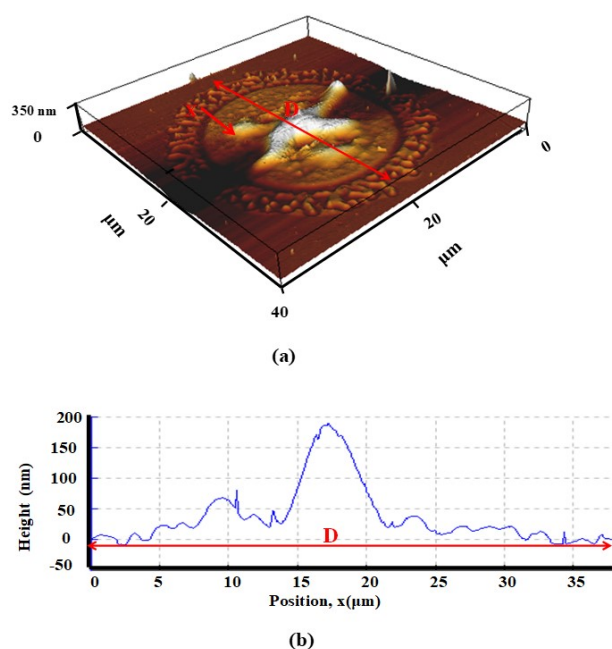
Figure 9: (a) Three-dimensional AFM image of the damage area and (b) a corresponding extracted height profile scanned across the profile line for the ITO/Ag-alloy/ITO film sample submerged in the 0.3-M NaCl solution for 57600 s. A red line and a red arrow in panel (a) indicate the positions of the extracted profile and the x direction.

The samples immersed in 0.3 and 3 M NaCl for 57600 s were investigated using AFM to characterize the corrosion spot topography of the ITO/Ag-alloy/ITO film. As the three-dimensional AFM micrographs in Figure 9(a) demonstrate, the damage area for a sample immersed in the 0.3-M solution consists primarily of circular blisters that appear to form folds in the top ITO layer, indicating interlayer delamination. The Ag layer was clustered, and its clustering, or agglomeration, was clearly seen all over the damaged area, even though the agglomeration of the Ag film is thick at the center and the height of the agglomeration at the center area is about 175 nm, as the cross-sectional AFM micrograph shows in Figure 9(b). This indicates that the Ag agglomerations appear to be mobile once they are formed. However, when a sample is exposed to the 3-M solution, most of Ag

has agglomerated at the center point of the circle with the height of around 80 nm with some parts appearing along the circumference with a height almost equal to 15 nm [Figure 9(b)].

Furthermore, it is observed from Figures 9(b) and 10(b) that the spot size decreases significantly with increasing the solution concentration; the spots with approximately 37 and 9 μm in diameter were observed for 0.3 and 3 M, respectively. This is because the diluted solutions can not be sustained, allowing the growth into the spot region to continue, whereas thicker solutions allow a deeper attack in the small spot region.

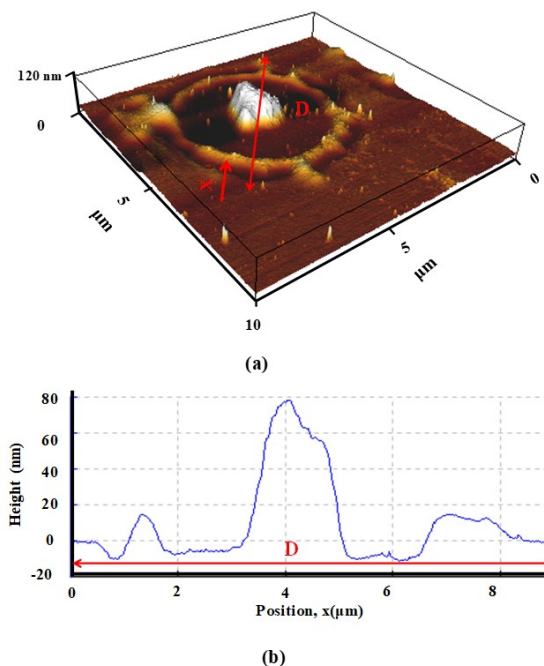
Figure 10: Same as Figure 9, but the sample was immersed in the 3-M NaCl solution.

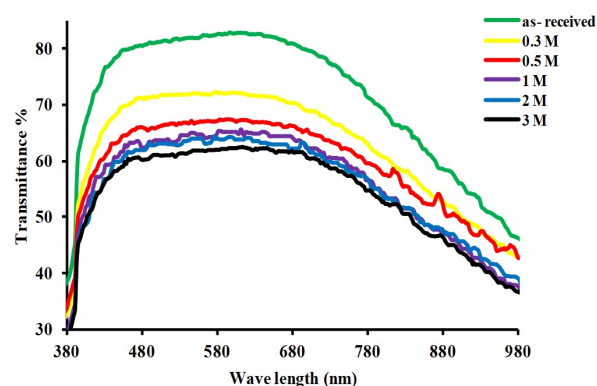
Figure 11: The effect of various concentrations on optical transmittances of the flexible ITO/Ag-alloy/ITO film after 57600 s.

Figure 11 exhibits the transmittance curves of ITO/Ag-alloy/ITO films immersed in various concentrations of NaCl for 57600 s. For comparison, the transmittance of the as-received ITO/Ag-alloy/ITO thin film is also presented. As a general trend, the transmittance of the ITO/Ag-alloy/ITO films after being submerged in the NaCl solutions was compared to that measured for the as-received specimen. In particular, the transmittance of ITO/Ag-alloy/ITO significantly decreased after being immersed in 3 M NaCl. This is likely due to the existence of several corrosion spots (Ag agglomeration) on the surface which cause surface roughening and an increase in the scattering of the incident light [9]. Similar observations have also been reported by Sahu *et al.* [22] on Ag films exposed to 200°C for 30 min. They attributed the decrease in transmittance of the Ag film to the agglomeration of Ag and consequently to the enhanced scattering of the light. These results are also consistent with

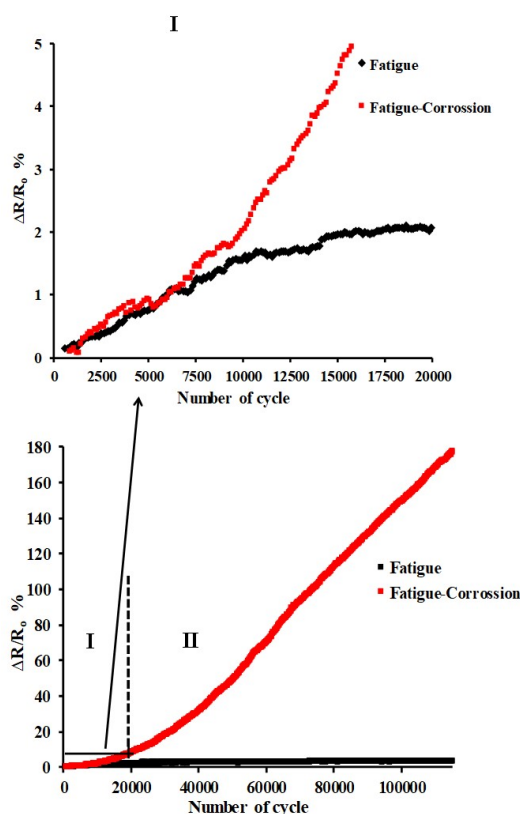
Figure 12: Normalized electrical resistance versus the number of cycles of ITO/Ag-alloy/ITO under bending fatigue and bending fatigue-corrosion conditions. The upper inset represents the enlarged result up to 2000 cycles, which clearly reflects the initial increase of the electrical resistance.

Figure 12 shows the percentage increase in the electrical resistance as a function of the number of cycles under fatigue and fatigue-corrosion. The mechanism of bending fatigue appears to be similar to that observed in our previous work for the twisting fatigue test [24], and the observed increase in the electrical resistance can be split into two distinct regions. In the first region (region I), the increment in the normalized electrical resistance is associated with the dimensional change of the compliant substrate until an equilibrium size is attained [25]. In the second region (region II), the gradually increasing resistance is likely to be due to cracking of the ITO/Ag-alloy/ITO film.

The mechanism of corrosion-fatigue in region I is similar to the fatigue-only case. However, in region II, the high rate of the electrical resistance increase was observed (Figure 12). For example, at the same applied strain of 0.5% and 115200 cycles, the sample under fatigue-corrosion exhibited an increase of the resistance of ~177%, which is significantly higher than that of ~3.4% for the sample under fatigue only.
